Manhole Inspection Summary

Manhole # S65E__008MH

Insp Date: **3/14/08 11:06 AM**

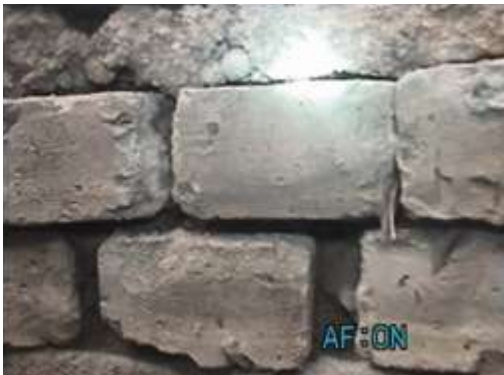
Defect 2

Condition: ☐ Sound ☐ Cracked ☐ Root Intrusion ☒ **Loose Brick** ☒ **Deteriorated**

Infiltration: ☐ None ☒ **Joint** ☐ Cracks ☒ **Mortar** ☐ Roots ☐ Wall

Loose bricks/missing mortar from chimney into corbel.

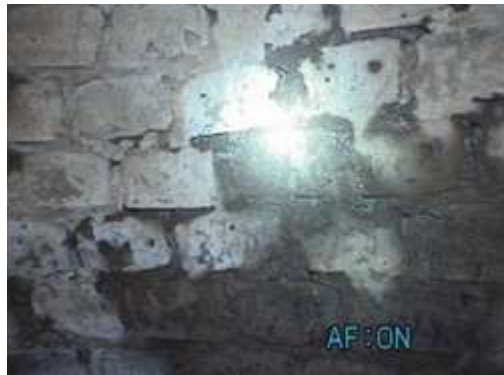
Defect 1

Infiltration: ☐ None ☐ Joint ☐ Cracks ☒ **Mortar** ☐ Roots ☐ Wall

Infiltration: ☐ None ☐ Joint ☐ Cracks ☒ **Mortar** ☐ Roots ☒ **Wall**

Infiltration in corbel/barrel

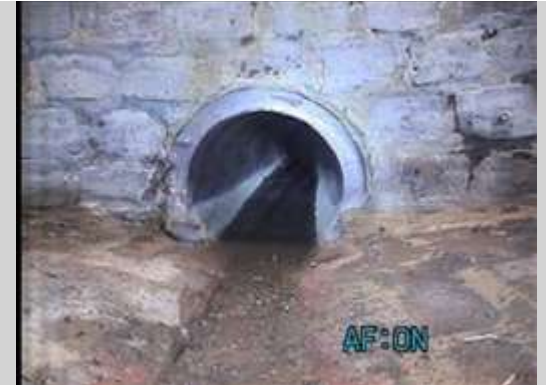
12 O'Clock Outflow

8 in. Circular Gravity Sewer
Pipe Out @ 12 O'Clock

Infiltration: **None** Pipe Seal Cond: **Sound**
